An Experience of Ageing on XLPE Insulation

W. G. Ariastina^{a*}, A. I. Weking^a, I. N. S. Kumara^a, I. A. D. Giriantari^a, I. N. Sugiarta^b

A case study of ageing on XLPE conductor insulation of 20kV primary distribution feeder is presented in this paper. The insulation degradation mainly occurred around conductor tie where the conductor is attached to the post insulator. A section of distribution feeder with defects on the conductor insulation has been examined for this study. Potential losses due to presence of discharges have been investigated by measuring the difference current at locations of the affected conductor. Temperature measurements of the insulation surface have also been carried out. Provisional maintenance procedures were introduced to eliminate the discharges. Measurements of current and surface temperature were repeated nine months after completion of the maintenance work. Results indicated that the discharges have been completely disappeared.

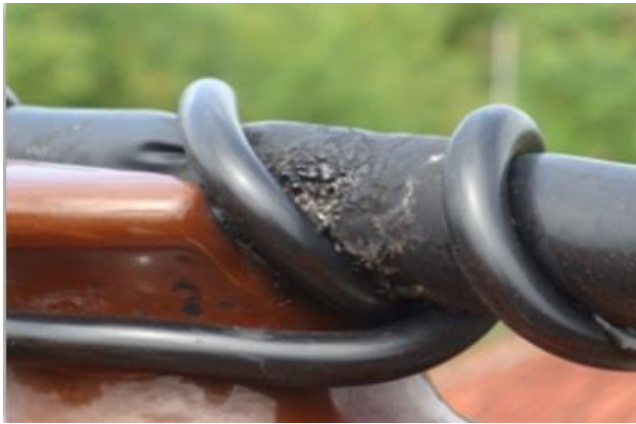
Figure 1 shows a part of degraded insulation of the conductor. The conductor is attached to the top of a post insulator and is tied using a polymer string. It is clear that the XLPE insulation of the conductor has been burnt thus reducing its insulating capability. This condition is as a consequence of the occurrence of discharges on the conductor section.

Figure 1 Sheath degradation of AAAC-S

In early period of utilisation of the AAAC-S in South and East parts of Bali, the installation procedure of the conductor followed the installation of the AAAC. Mishandling of the AAAC-S during installation may damage the XLPE sheath, which is later causing discharges. The presence of discharges and the involvement of water and other pollutants in chemical reactions certainly will further deteriorate the insulation rapidly.

Another issue related to the AAAC-S installation is the use of metal strings to tie the conductor on the post insulator. Because of the XLPE sheath of the AAAC-S is not designed to fully isolate the conductor, thus strong electric fields on the XLPE sheath surface may exist. The metallic conductor tie thus behaves like a floating material and may introduce potential difference. If the potential difference between the two is sufficiently high, then discharges may occur.

During maintenance of the damaged XLPE sheath, different methods were introduced in addition to removal of the burnt insulation. Polymer strings were used to replace the metal strings for conductor tie. The existence of the electric field on the XLPE sheath was reduced by means of intrusive needles tied on both ends of the strings. This removes the potential difference between the conductor and the strings. It should be noted here that the introduced methods are for experimental purpose only. Although these methods have successfully removed the discharges, more proper and standardised methods must be followed.

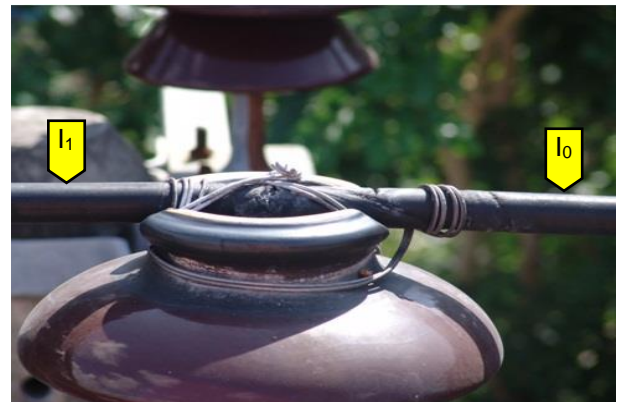
Figure 3 depicts the locations of current measurement near a conductor tie of a section with damaged XLPE sheath. The markers on the picture are for indication only. The exact locations of current measurements were further left and right to accommodate all damaged insulation segments. The clamp meter used to measure I₁ has similar characteristics to that used to measure I₀.

Figure 3 Location of current measurements

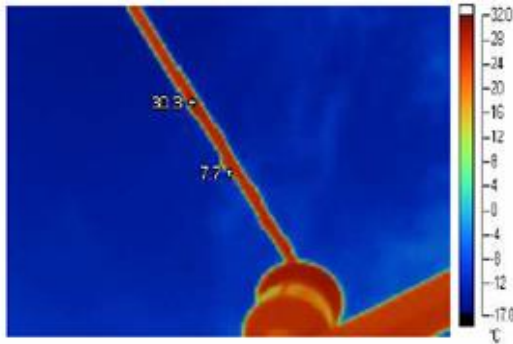
Figure 4 shows a typical image from the utilised thermo vision camera. The camera may identify a temperature variation within the aimed area. The average temperature of the conductor sheath near the discharge locations were recorded for this study.

Figure 4 Typical image from the thermo vision camera

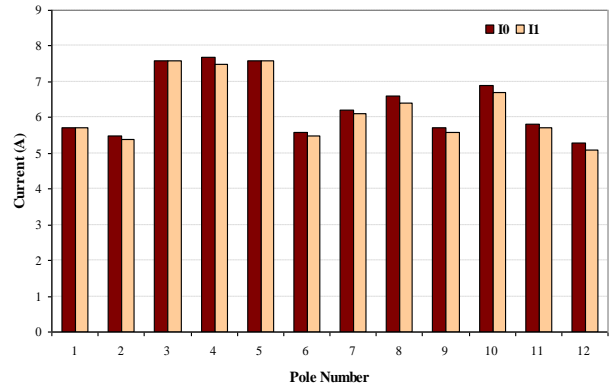
The measured quantity of flowing current on the conductor depends on the load of the remaining part of the feeder at the time of measurement. The magnitude of difference current varies from point to point of measurements, with an average value of 0.108A for the red phase and of 0.117A for the yellow and the blue phases. This evidence is depicted in Figure 8, where less discharge events occurred on the red phase compared to that on the yellow and blue phases.

Figure 5 Measured current of red phase

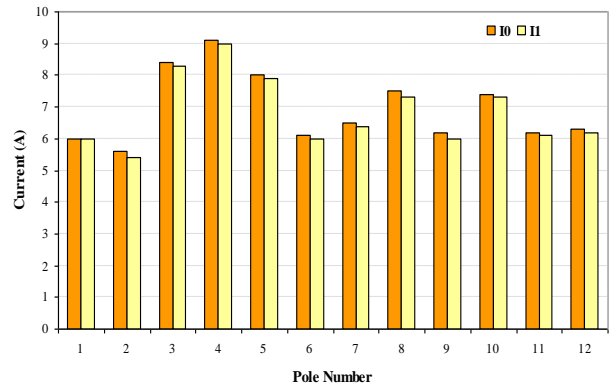
Figure 6 Measured current of yellow phase

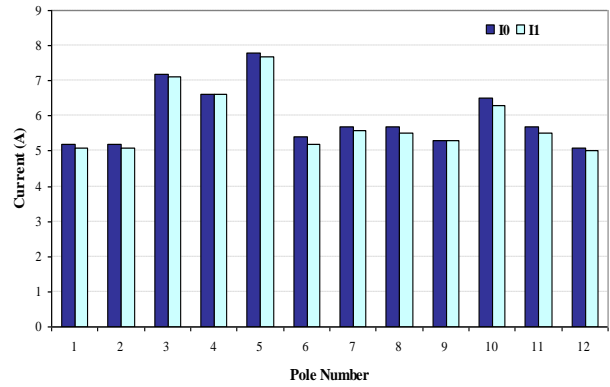
Figure 7 Measured current of blue phase

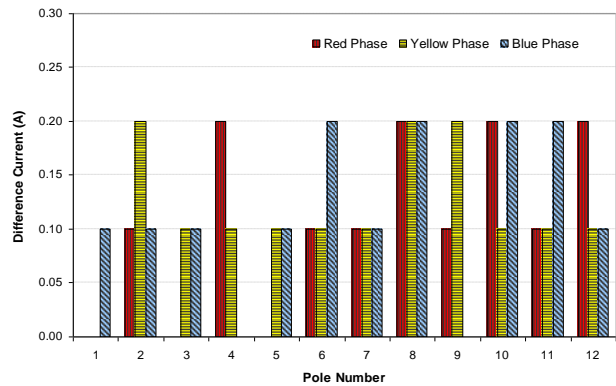
Figure 8 Difference current measured at the twelve poles

Potential power loss at all phases was identified at seven out of twelve explored poles, while potential power loss at only one phase was discovered for one pole. This fact indicates that the insulation damage occurred around conductor tie at all the investigated twelve poles. The results also designate that at 91% of the total number of poles, the insulation ageing involves two or more phases.

Following the identification of defects on the XLPE insulation, immediate life maintenance works were carried out to prevent further defects on the conductor. Measurements of the flowing current were repeated after completion of the maintenance. There was no indication of difference current during the second measurement.

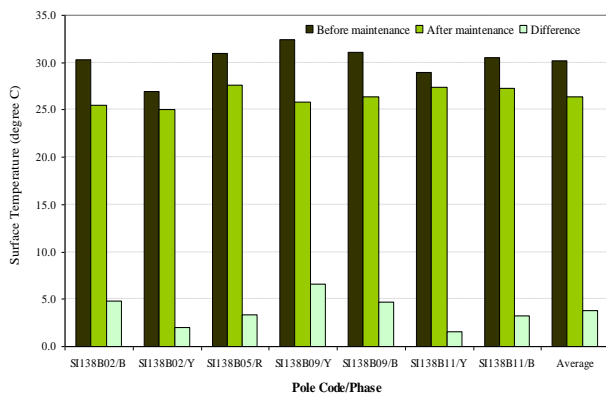
Figure 9 shows the surface temperature of the XLPE sheath before and after maintenance works at a number of investigated poles and particular phases. Note that not all defect points were measured for surface temperature. Measurements were carried out randomly on poles with an identification number of 2, 5, 9 and 11, as shown in the figure. The average temperature of the XLPE sheath surface near defect locations (before maintenance) is slightly above 30°C. In contrast, after completion of the maintenance works, the approximate average XLPE sheath surface temperature became 26.5°C. There was a reduction of about 3.5°C in surface temperature of the XLPE sheath after maintenance process was completed.

Figure 9 Surface temperature of the XLPE sheath
